# Manhole Inspection Summary

Manhole # S23MM1012MH

Insp Date: **11/20/06 10:19 AM**

**Location** Address: **1401 OLD COLD SPRING LN**

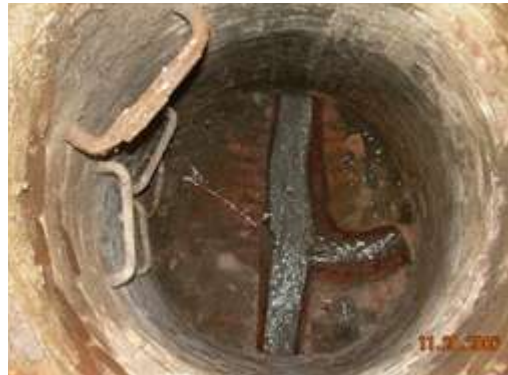
Top View

Infiltration: ☐ None ☐ Joint ☐ Cracks ☒ **Mortar** ☐ Roots ☒ **Wall**

☒ **Debris** (not Condition related)

Count: **5** Missing: **0** ☒ **Corroded**

Barrel infiltration. Corroded steps. Bench debris.

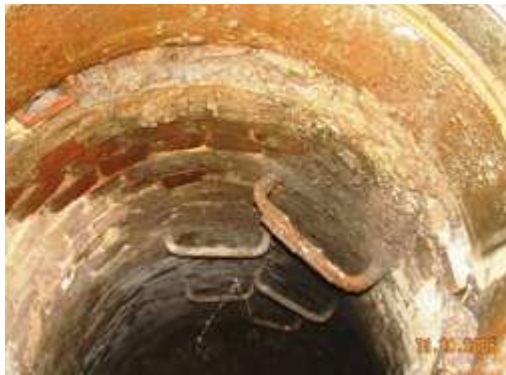
Defect

☒ **Leaks**

Condition: ☐ Sound ☐ Cracked ☐ Root Intrusion ☒ **Loose Brick** ☒ **Deteriorated**

Infiltration: ☐ None ☒ **Joint** ☐ Cracks ☒ **Mortar** ☐ Roots ☐ Wall

Frame leaks. Adjustment infiltration, loose brick, and deterioration.

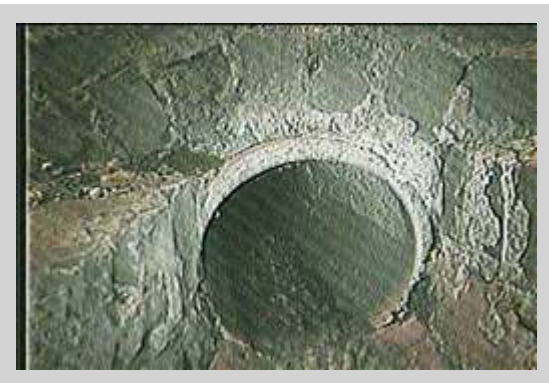
### 8 in. Circular Gravity Sewer Pipe In @ 2 O'Clock

Condition: ☐ Sound ☐ Cracked ☐ Root Intrusion ☒ **Deteriorated** ☐ Leaks ☐ Debris

Channel deterioration.
